Bulletin No. 06-006
Issue/Revision: 01
Prepared By: Julian Rickards
Approved By: Gary Male

Subject: Board Change Notice For SIPS2 Transceivers

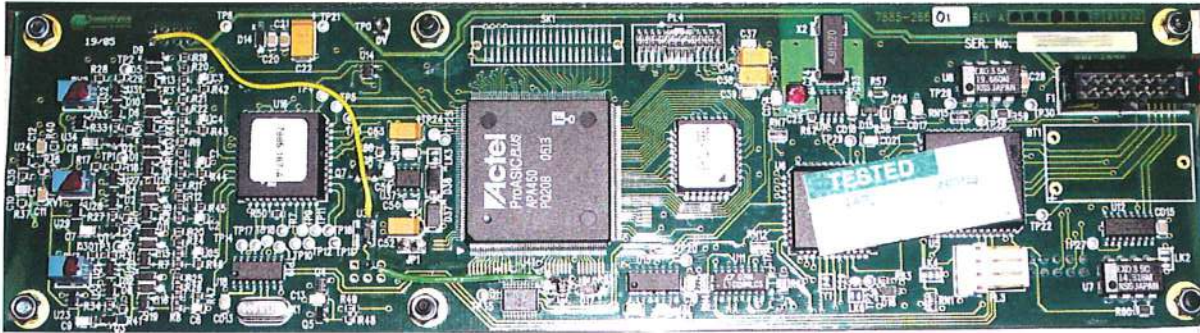
Appearance of the product (Below):

SIPS 2 transceivers containing: 631-7461 – SIPS FPGA CPU PCB ASSEMBLY 7885-266 (Issue <A7)

The board can be identified by the markings at the top right, affected boards have the following marking:

The potential failure mode is now well understood, we therefore have developed a comprehensive solution which involves a minor modification to the CPU PCB: this rework can be completed in the field by semi-skilled engineers, however to ensure a controlled methodology is employed we recommend that each unit is returned to our offices in Blackbushe, UK. We will contact each customer to ascertain the most suitable method of rectification according to customer circumstances.
