## **Marksman & Ranger 2 Release Notes**

### **Release Notes 6.04.06**

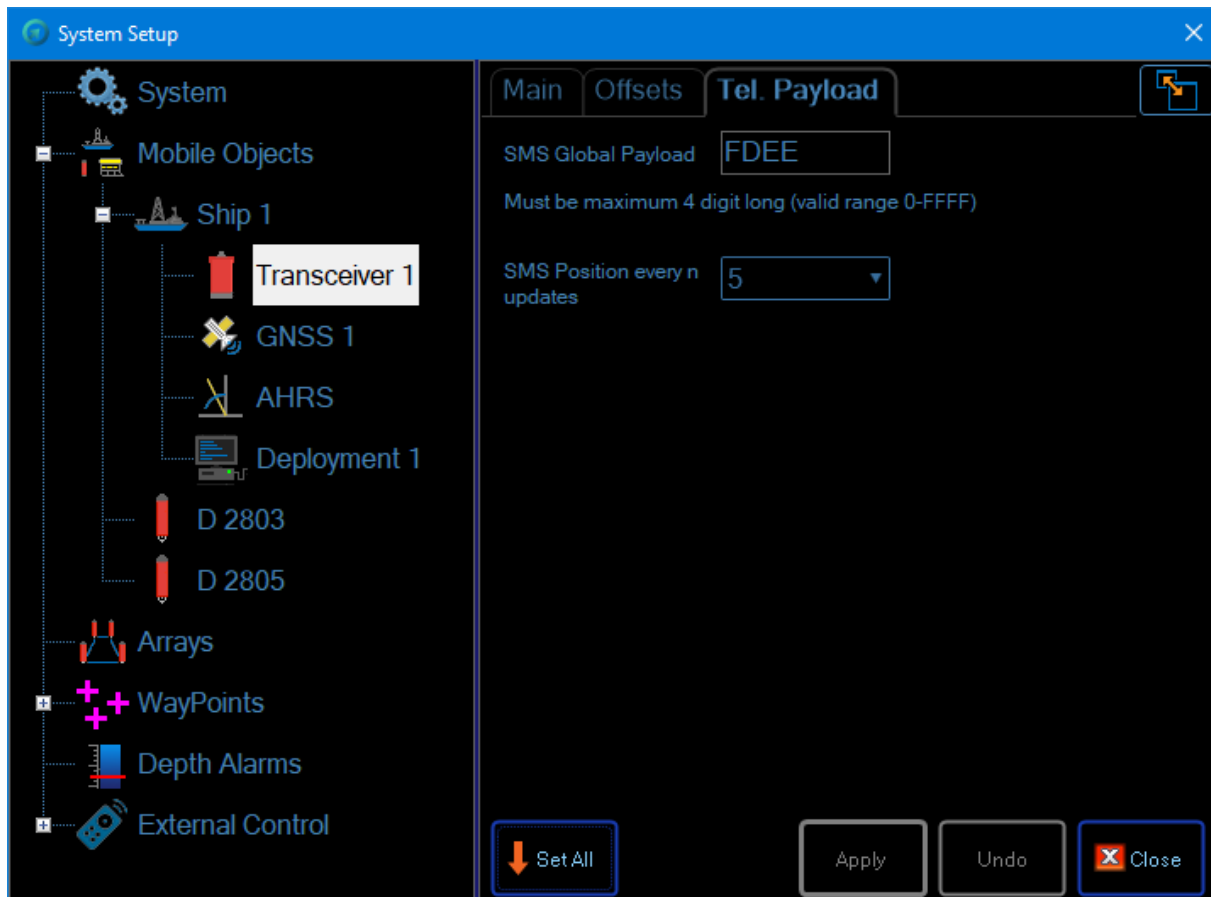
### MMR2-34505 Robotics: Add SPOS update every Nth cycle in normal ranging.

In situations where telemetry is difficult it is now possible to range using normal navigation signals, and then intersperse an SPOS every Nth update to minimise reverberation in the water column.

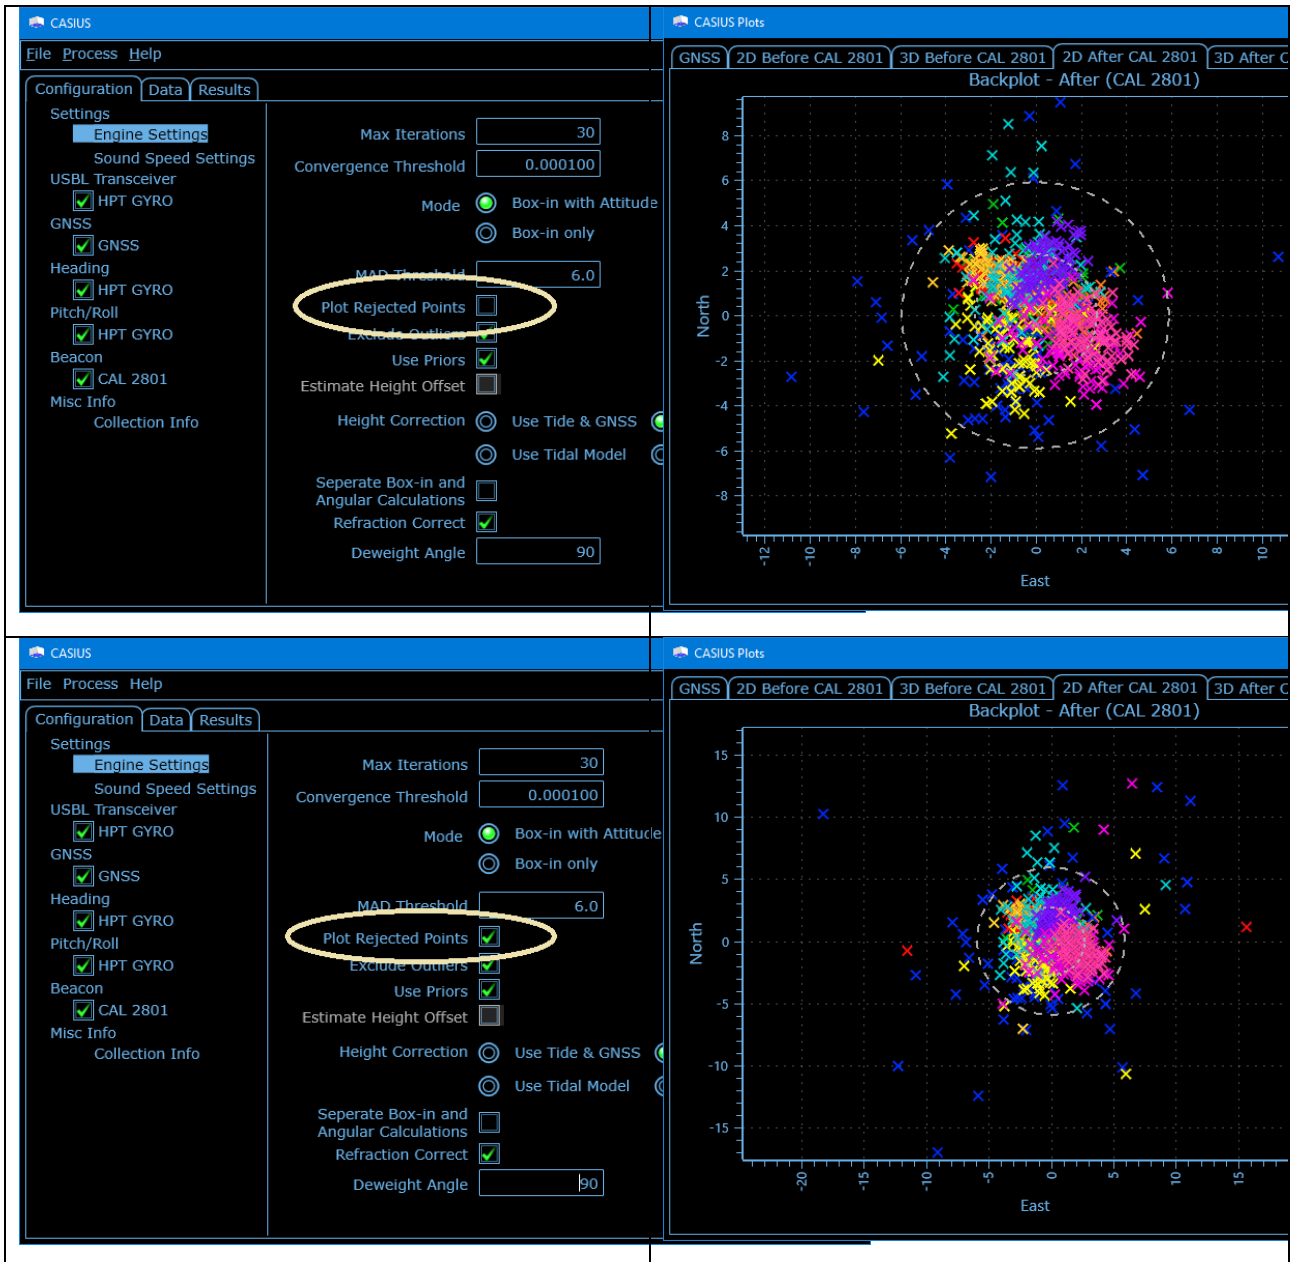
## MMR2-32967 Remove excluded data from the after plots

Previously all observations (including those that had been excluded) were shown on the CASIUS calibration result plots. By default, this data is now not plotted so that the charts auto-zoom to show the result more clearly. If the user wishes to see the excluded observations, then select the 'Plot Rejected Points' option in the 'Engine Settings', and re-process the CASIUS to generate new plots:
