<b>SONARDYNE INTERNATIONAL LTD.</b>

<b>TECHNICAL BULLETIN</b> <b>Use of Protective cover on L/USBL Transceivers</b>			
<b>No: 04-012</b>	<b>Issue: 1</b>	<b>Date: 7. 12. 04</b>	<b>Page 1 of 3</b>
<b>Prepared By:</b> Bernard Kiddier	<b>Title:</b> Applications Support Manager	<b>Sig:</b>	<b>Date:</b> 9/12/04
<b>Checked By:</b>	<b>Title:</b>	<b>Sig:</b>	<b>Date:</b>

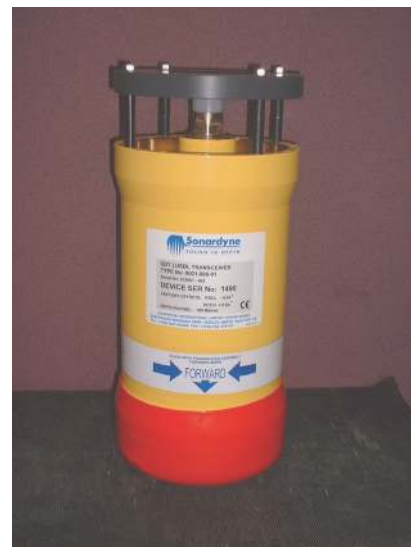
Red Cover Fitted

A red protective cover ( element end protector) is provided as standard with new L/USBL transceivers and is used to protect the face during transit and installation. **This cover must be removed before deployment as it will detrimentally effect the acoustic performance of the transceiver.**

For portable USBL systems where the transceiver is installed and removed from vessels on a regular basis, this red cover is to be retained and fitted on the transceiver during installation and decommissioning. This is to ensure that that the transceiver face is protected right up until the transceiver is either ready for deploying, at which point it must be removed, or as soon as it has been recovered from the water.

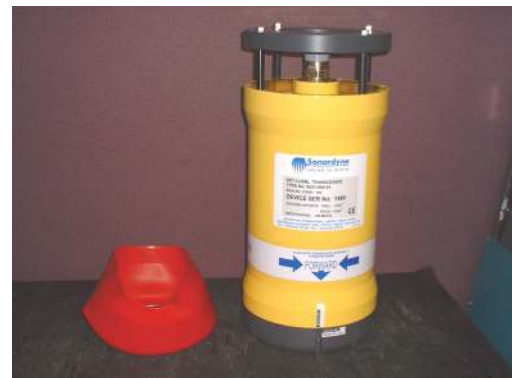
Red Cover removed
